Hackfall

Newsletter 3

Spring 2008

Progress at Hackfall

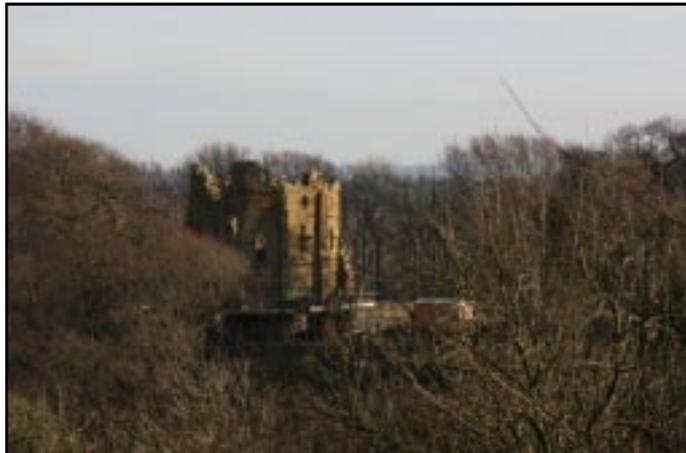
Mowbray Castle
Photograph: David Rodway

The project team adopted a conservative method of repair, the aim was to retain the patina of age while reinstating the structural integrity of the castle. To the untrained eye it may look as though little has been done, but the majority of the repair work is concealed behind the original stones. The contractor, John Maloney, and his team of

specialist masons, carefully unpicked areas of the facing stone to reveal the hollow core behind. Working in small sections, they rebuilt the core then reinstated the original facing stones. Wall tops were protected with stone flags and the masonry was repointed. Over two hundred bags of lime and three times that quantity of sand were used in the consolidation of the core and repointing of the external wall faces.

The old stone was retained wherever possible, however eroded. Gaps in stones were repaired using stone tiles; stones were only replaced as a last resort, where the existing stone had lost its structural integrity. The good matching stone was obtained from a local quarry near West Witton, though it looks very new at present, the humid woodland environment will soon encourage lichen to colonise the cut faces and blend with the old. Mortars were carefully designed to match as closely as possible to the original and incorporate crushed limestone and charcoal to mimic the texture of the original pointing.

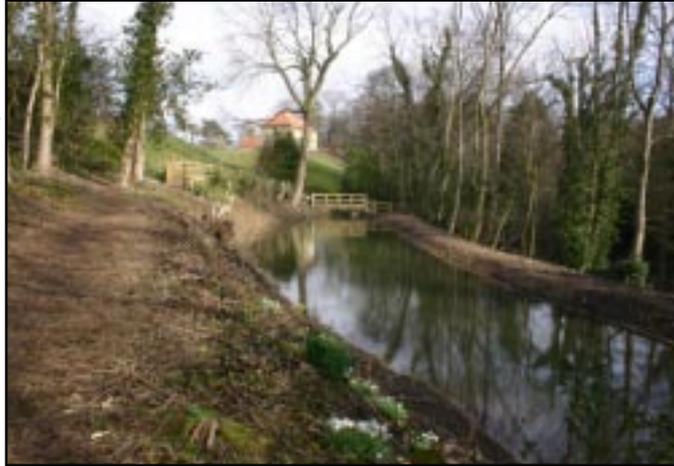
Grewelthorpe Beck Pool
Photograph: David Rodway

sought. The options were full restoration with a subsequent loss of vegetation, versus no restoration possible with no loss of vegetation. Obviously, in order to restore the Aislable garden design the restoration of this upper pond, opposite Hackfall House, was critical and the proposal was put forward by the Hackfall Trust to restore the pool to a slightly shorter version than the original, losing less woodland vegetation, and opening up the original wicket

gate entrance, on the road side of the pool. As this had originally been the path the vegetation was largely ivy and bramble, much less valuable ecologically than the woodland species found on the far side, where as a further compromise the path has now been closed to allow the vegetation to recover and to provide an attractive backdrop to the newly restored pool.
